# HISTORIC PROPERTY INVENTORY FORM

**Field Site No.** 6652-H **OAHP No.** \_\_\_\_\_ **Date Recorded** 25 June 1993  
**Site Name Historic** H-52 Nike Missile Base - Mess Hall **Revised** 14 July 1994  
**Common** Arid Lands Ecology Reserve Radioecology Laboratory 1 March 1997  
**Field Recorder** Rance Bayman/A. L. Mitchell/D. W. Harvey  
**Owner's Name** U. S. Department of Energy, Richland Operations Office  
**Address** P.O. Box 550  
**City/State/Zip Code** Richland, WA 99352

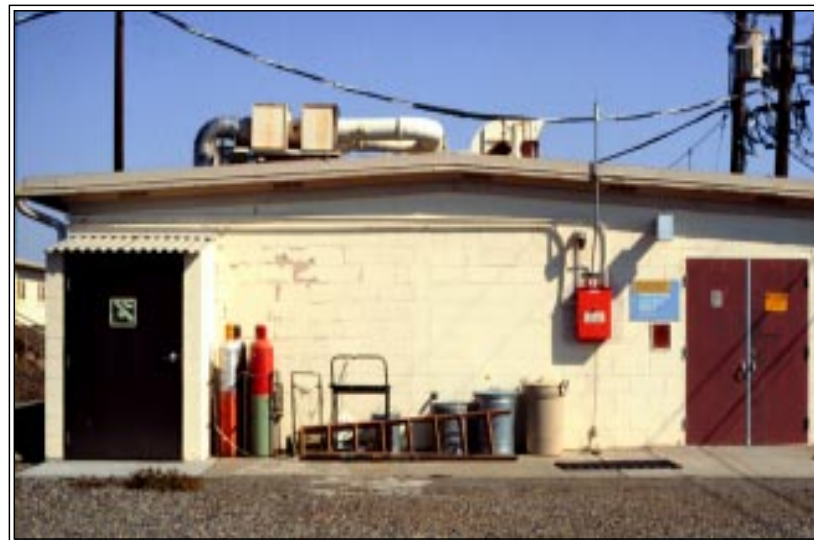
Photo at right: Roll 124, frame 9  
View of south facade

The perimeter of the main 6652-H building measures 90' x 30', with additions totaling 8' x 14' and 46' x 21'6". The building's west wall contains a section that appears to have been a doorway, but is now filled in with concrete block. This is similar to the concrete block material used in the exterior wall. The south wall has a small extended entryway on the western side. The east wall also had a doorway that has been filled in with concrete block. The windows appear original, double-paned and wood framed. Medium gauge chicken wire or wire with a "diamond pattern" is between the glass panes. The northeast end of the building has been modified with an addition that connects Building 6652-H Mess Hall and the 6652-I Administration Building. The double windows of the addition are metal framed. These windows are not of the sash-slide method as are the double-paned windows with wire. There is a single, metal door on the northwestern end that both the addition and the 6652-H building share. There is a single, metal door on the south wall of the addition that leads to the unloading parking lot. The interior of the 6652-H building has obviously been subdivided into lab space in the western two-thirds, with a hallway on the eastern side. This hallway connects up with the addition that has offices on the north side. The interior of 6652-H and the addition are characterized by drop ceilings. The original ceilings could quite possibly be intact above these. The building is currently abandoned.
